# Bull Session The Search for Two Missing US Army Air Force Airmen and Their B-17 Bomber

PATRICK L. MURPHY

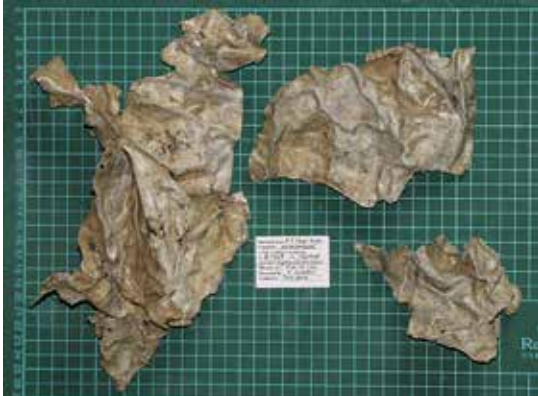
Exhaustive searching yielded very little wreckage in the area, only a few pieces of aluminum. In a 4.5km area of the Béigerhaard, less than 30 pieces of evidence were found spread over a kilometer, the smaller fragments most likely came off in the initial explosion (Fig 3.2, Fig 4.1).

(Fig. 3.2) — Aircraft aluminum skin fragments  
(Photo P. Murphy © WWIIBRPG).

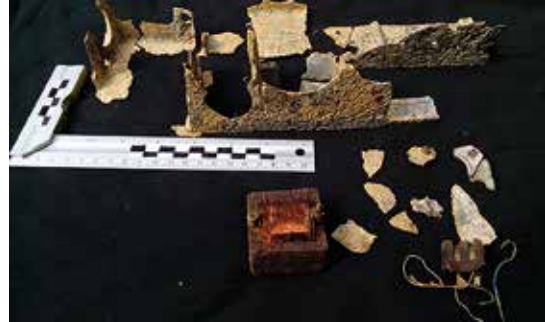
(Fig. 4.1) — Fragments of suspected electronic equipment  
(Photo P. Murphy © WWIIBRPG).

Photo (Fig 4.1) shows possible electronics/radio items found in the forest; certainly, these items of lighter debris fell directly out of the aircraft as the ship was ripped open by the initial explosion. This explosion also sent the three forward crew members out of the plane and to the ground. After the war, they were all recovered by the Graves Registration Company and given a reburial in US Military Cemetery Foy, and then again to Henri Chappell or sent home. In the spring of 1946, the Pilot, Lt. William E. Meyer, was found in a shallow grave by Mrs. Anna Jaeger, gathering wood off a forest trail near the Béigerhaard. Lt. Meyer was then sent home to Texas where he was buried in a family cemetery. Consequently, documents show that the Co-Pilot Laurin P. Otting was likely "shot" at and died of his wounds in the German infirmary in Boevange, then temporarily buried near the church and now rests in Henri Chappell US Military Cemetery.

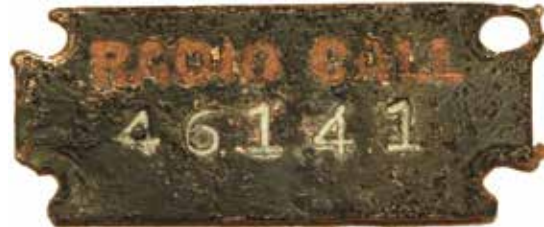
(Fig. 4.3) — Radio Call plate found identifying the Weicherdange wreck site (Photo .P Murphy © WWIIBRPG).

In June of 2020, the evidence, (Fig 4.3) a radio call plate with the plane's serial number, was finally discovered and the Weicherdange plane identity was confirmed to be a plane from the 384th Bomb Group, 544th Bomber Squadron. This plane had finally been identified as "Sneakin Deacon" (MURPHY 2020). This plane was not "Bull Session".

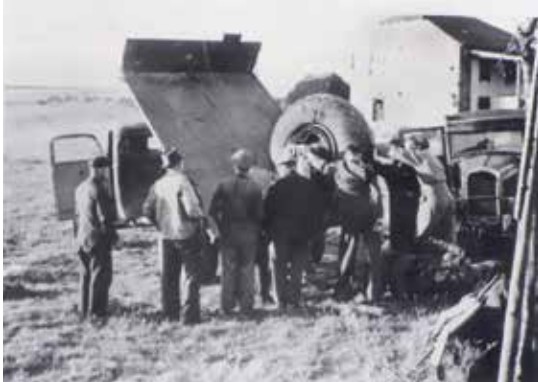
Two particular pieces of information given in CRASH II (DERNEDEN 2004) were the photographs of the landing gear (Fig 5.1.2) being loaded on a truck in Knaphoscheid, and the upper-turret (Fig 6.1) in the woods, supposed to be the Béigerhaard. Questions were asked about

(Fig. 5.1) — Landing struts and wheel gear being loaded in Knaphoscheid (Photo M. Schmitz, J. Derneden, *CRASH-II*).

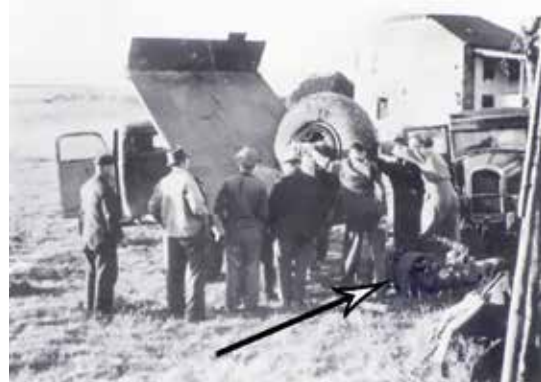
(Fig. 5.2) — Pointing out the fact that there is a second landing strut in the photo (M. Schmitz, J. Derneden, *CRASH-II*).

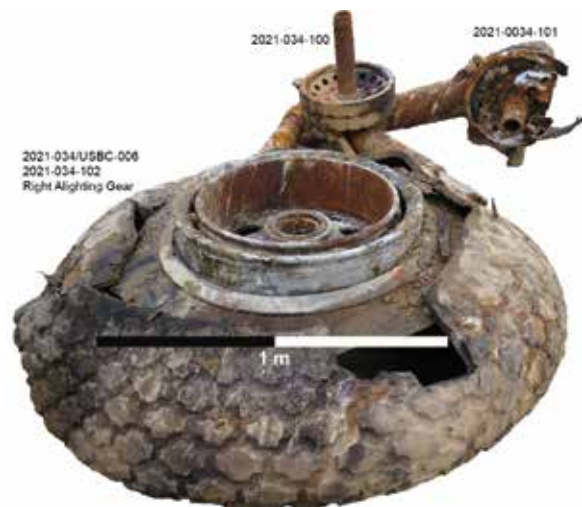
those items and if it was known where they were found. There was no such data known about the wreckage locations. An investigation conducted on these wreckage pictures finally identified the farm and some of the men in the photos to be from Knaphoscheid, one of these men owned an *épicerie* and had the only GMC truck in the area. It was presumed that this landing gear came from the Weicherdange wreck, and postulated that the upper turret was also from the Weicherdange wreck. An in-depth analysis of the photos shows that both landing struts are in the photo, (Fig 5.2) but not previously seen (Fig 5.1). It was then deduced that this wreckage must be of the Weicherdange plane, and if the wreck of Bull Session was to be found with enough evidence, it could prove that this theory was correct, which turned out to be the case. As both complete landing struts and tires (Fig 5.3) were found in the “Wind turbine” site.

(Fig. 5.3) — Left wheel/tire and main landing struts of right and left aligning gear from Bull Session, USBC-006 (Photo P. Murphy © WWIIBRPG).

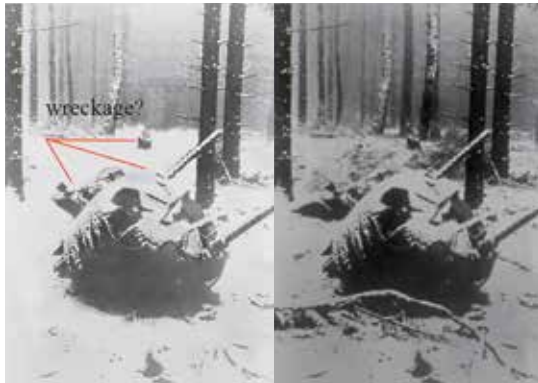
The upper turret (Fig 6.1) is fairly complete with light damage. Also, both guns are present, therefore, we assume that the gun carriage frame and all attachments are also inside; for

(Fig. 6.1) — Cleaned up photo (L) of upper turret exhibiting more debris in the picture (J. Derneden, *CRASH-II*).

that reason, there should be no duplication of parts i.e. same pieces in the picture also found at the “Wind turbine” site.

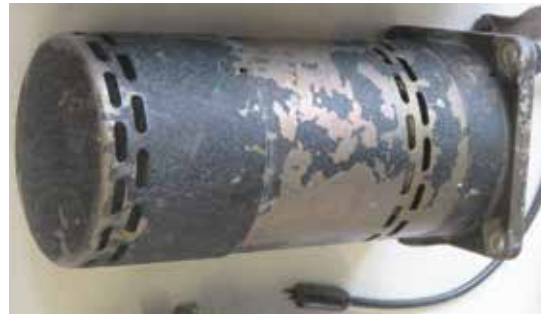
(Fig. 6.3) — Amplidyne 28/60vlt motor at the General Patton Memorial Museum (Photo P. Murphy © WWIIBRPG).

The electric motor (Fig 6.3) is typical of Bendix turret drives, but this one appears to have been taken shortly after the crash or from somewhere else? There were many of these 24 and 28-volt motors on the plane. But the *Sperry* upper-turret in Bull Session is driven by a singular hybrid “Electro-Hydraulic” motor with two hydraulic ends for azimuth and elevation control. The motor in the photo would not have looked like the one in the upper tur-

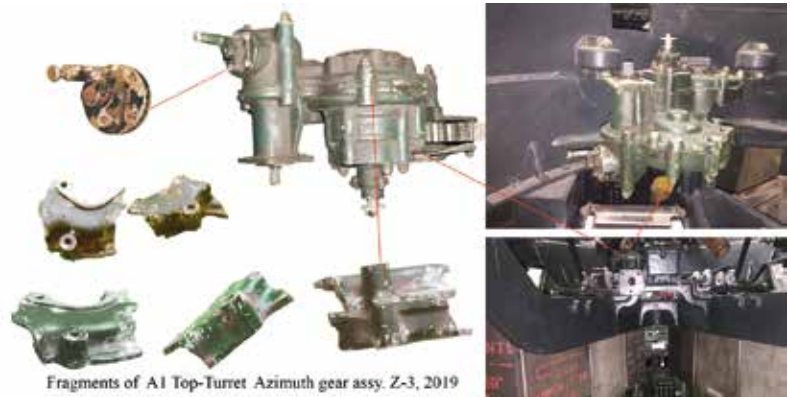
New evidence found in 2021 suggests that the upper turret of Bull Session was on the new crash site in the field. Fig 7.1 shows upper turret evidence found in Weicherdange and recent 2021 findings (Fig 7.2) of upper turret evidence.

(Fig. 7.1) — left, the fragments found are from the upper turret azimuth gear housing from the Weicherdange site of Sneakin Deacon. The photo right (David Littleton image) is the azimuth gear in position inside the upper turret trunnion ring; elevation gear has a similar housing but differs in mounting and size/shape (Photo montage P. Murphy © WWIIBRPG).

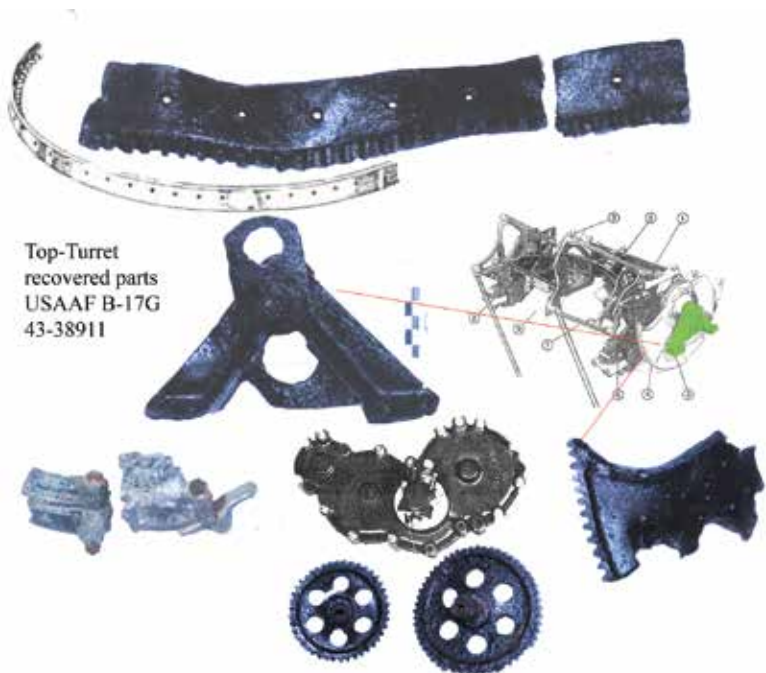
(Fig. 7.2) — Upper turret parts found at the "Wind turbine" site; some wreckage found on the field in the area that is now ground-zero for impact. Wreckage was also recovered from the deposit site (USBC-002) which the salvage crew threw into the pits. As more wreckage is being identified there is hope that more upper turret pieces will be discovered. This is very important to the research as the upper turret is the position last known for Sgt. Holowaty one of the MIA. If the turret hit ground zero then there is a chance that Holowaty may have been in or near it and therefore a slight possibility of being found on the site. Photo P. montage Murphy © WWIIBRPG.

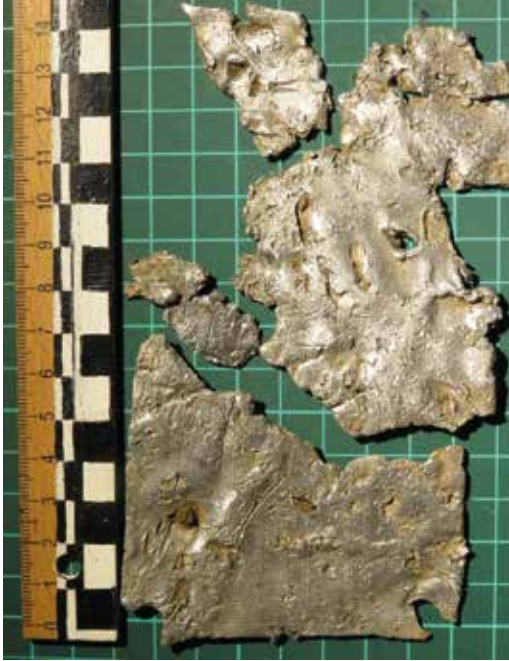
In late January, a fragment of the engine data plate was found (Fig 8.3), but it had only a part of the serial number. A couple of weeks later, the second half of the tag was found. The odds of locating one full tag let alone two halves in such a large area are extremely low. Note the shrapnel holes and one piece still in the plate.

(Fig. 8.3) — First engine data plate found 2021  
(© P. Murphy).

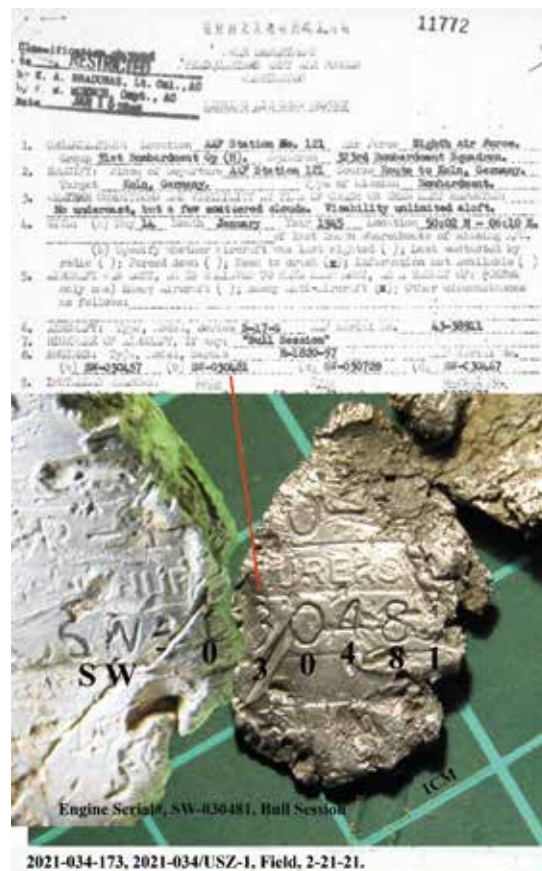
The serial number was compared to the listing on the MACR (Missing Air Crew Report) #11772, the first page that gives the basic data of the mission, crew, and serial numbers of each of the engines. Although heavily damaged, the data plate was a perfect match for one of the four engines listed in the report (Fig 9.1). At last, a piece of critical evidence found that was extremely important in identifying the wreck on the ground.

(Fig. 9.1) — Engine data plate. MACR 11772  
(Photo © WWIIBRPG).

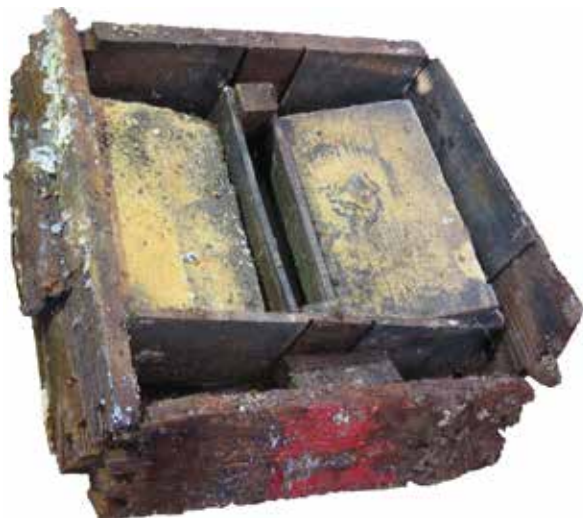
(Fig. 9.3) — Found lying under the elevator assembly (USBC-003) was this extremely rare find of a German wood mine with 2 Kg of active TNT (Photo © WWIIBRPG).

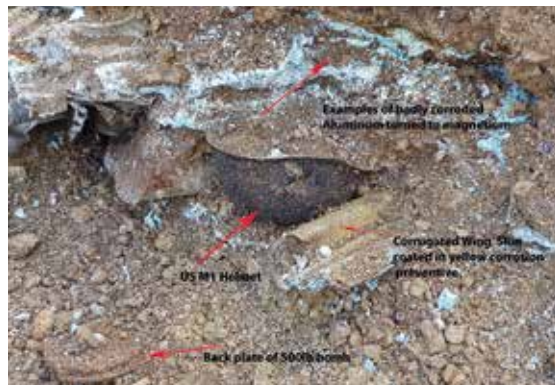
(Fig. 10.3) — Corrosion effects on iron artifacts versus aluminum (Photo P. Murphy © WWIIBRPG).

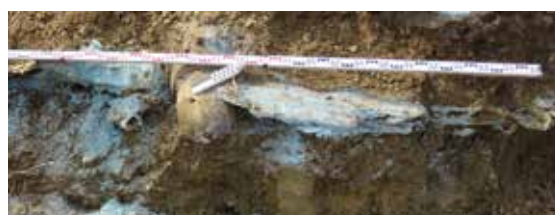
(Fig. 10.4) — Propeller blade showing extent of corrosion, and damage result (Photo P. Murphy © WWIIBRPG).

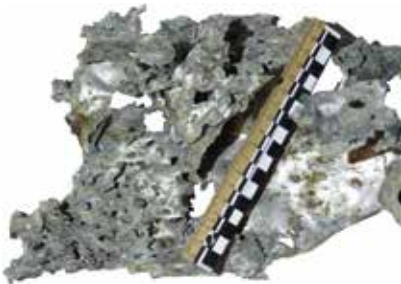
| (Fig. 13.2) — Frontal flak damage to an engine cover (P. Murphy © WWIIBRPG).

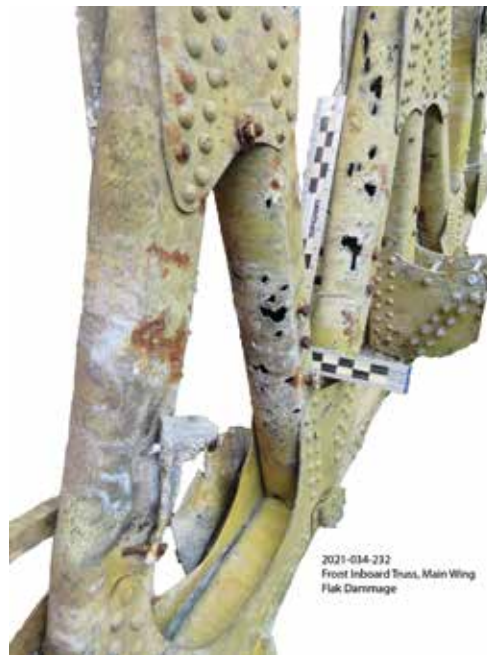
| (Fig. 13.3) — Flak hole damage to main wing truss (P. Murphy © WWIIBRPG).

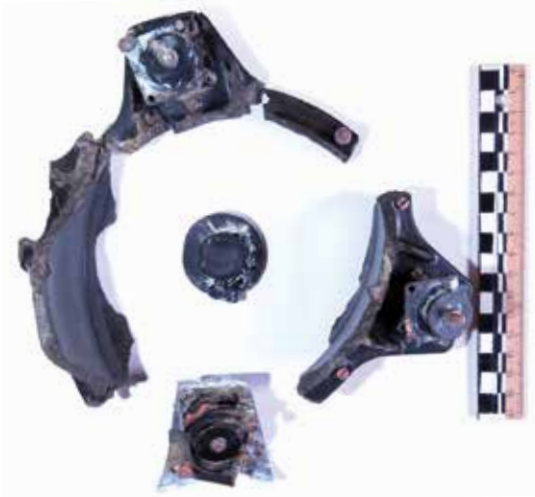
(Fig. 15.1) \_\_\_\_ Flux Gate Gyro transmitter- Bendix Corp located in the left wing.
