# Bull Session The Search for Two Missing US Army Air Force Airmen and Their B-17 Bomber

PATRICK L. MURPHY

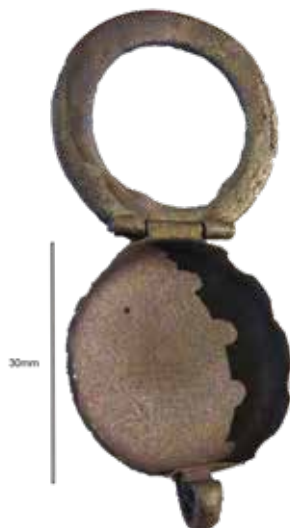
A locket thought to be Holowaty’s found by G.R.E.G (Fig 6.2) is from the Béigerhaard. It can be seen in the Patton Memorial Museum in Ettelbruck. The locket is typical early 1900s civilian use for pictures, not very common for the US military to carry.

(Fig. 6.2) — Photo-Locket from the Ettelbruck Patton Memorial Museum (P. Murphy © WWIIBRPG).

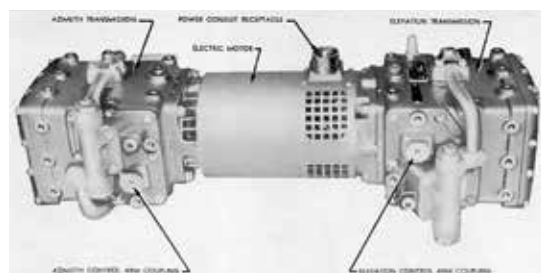
(Fig. 6.4) — Double power Electro-Hydraulic motor type, Sperry Overhaul Manual, Part-1 Upper turret.

The double power unit (Fig 6.4) that would have controlled the A1 upper turret in Bull Session was built by the Sperry Company, and has the electric power dynamotor in the center and is connected on each end by the hydraulic drives for independent azimuth and elevation control. This unit type is also used in the ball turret.

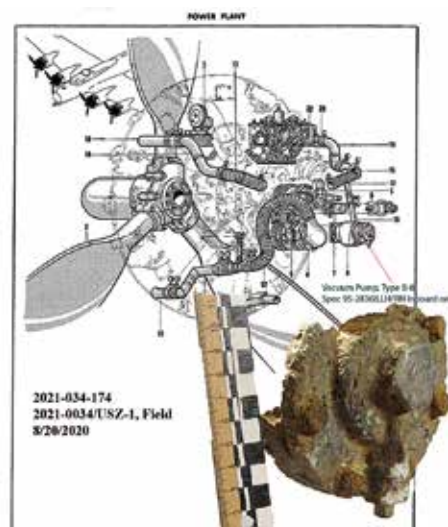
(Fig. 8.2) — Vacuum pump cover (B-17 Illustrated Parts catalog AN1-20EG-4, inset photo P. Murphy © WWIIBRPG).

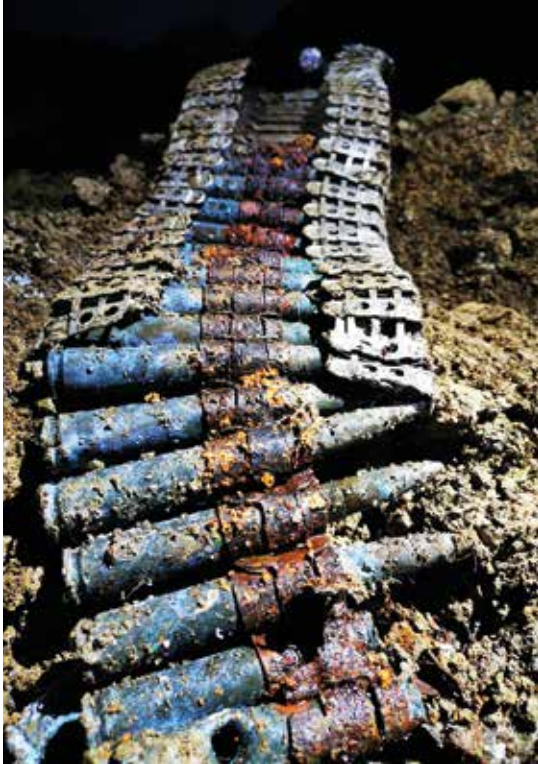
(Fig. 9.2) — Many of several 1000s of .50 ammunition recovered (Photo E. Grun-Murphy © WWIIBRPG).

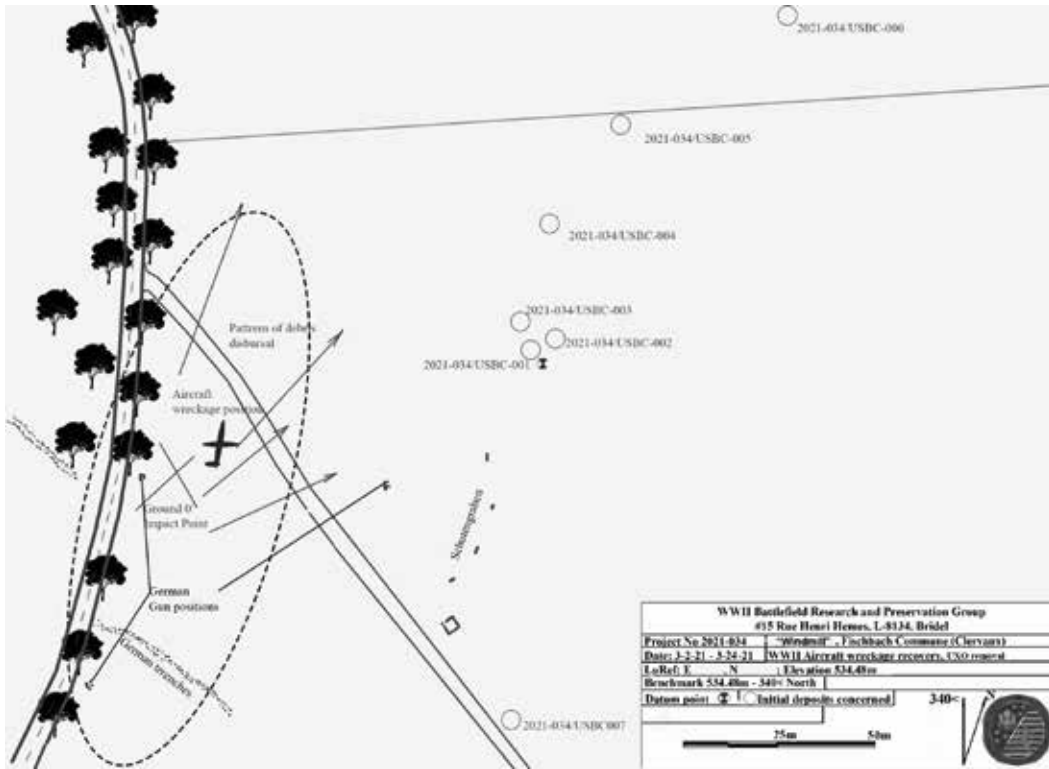
Geographically the crash route travel was in the Northern Ardennes transecting the West - North East direction from the southernmost section of the Béigerhaard forest near Boevange (Win-crangé) to the impact point (Fig 10.1).

(Fig. 10.1) — “Wind turbine” site and research area (P. Murphy © WWIIBRPG).

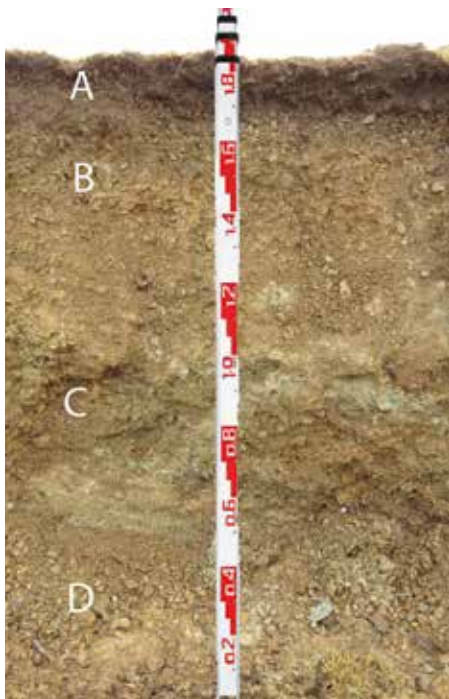
The weather and topography play a primary role in soil development or lack of. The site area is open crop fields with barely 25 to 30 cm of top-soil commonly called the "plow zone". (Fig 10.2) A= Plow Zone 20 - 30 cm, some artifacts seen in the layer of outer edges of the crater, B= Break-down from weathering, water, heat fertilizer, and cold: 30- 40 cm beginning of artifact zone, C= angled rock, broken /fractured from bomb shock, mixed iron oxide and shrapnel - shocked and heat damaged. Deposit zone of wreckage and artifacts 40 cm - 1.9 m. D= Bedrock, dense layer with little to no fracture from bomb shock 1.9 - 2.5 m.

(Fig. 10.2) — Illustrates ground changes within the wall of USBC-001, Munsell scale 10YR, 6/6 – 5/8 (P. Murphy © WWIIBRPG).

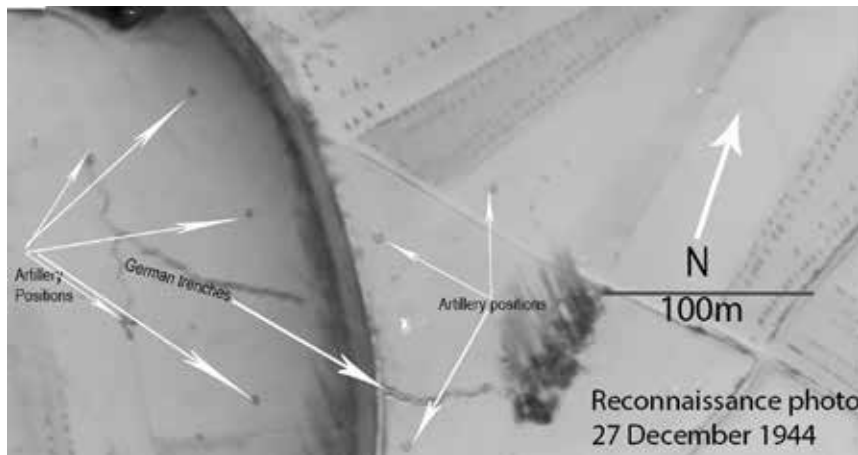
The site consists of craters formed end December 1944 when the US Air Forces dropped 500 lb (250 Kg) high explosive ordnance on German positions occupying the area (Fig 11.1). Seven or eight of these craters that have been located were used for dumping battlefield debris and

(Fig. 11.1) — Reconnaissance photo 27 December 1944 showing German positions, before the dropping of bombs, and the after photo (Fig 11.2) 14 January with wreck site in the picture (Photo NARA/NCAP).

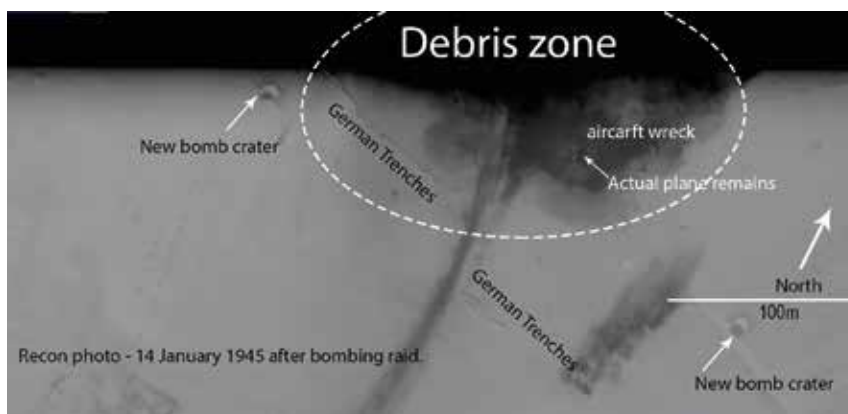
(Fig. 11.2) — Aerial reconnaissance photo taken 14 January 1945 shortly after the plane came down. The photos were to assess the damage done after the bombing and gather intelligence on new targets in the area. It was a stroke of luck that the wreck site happened to be in the photo shot and even greater luck discovering the picture. NARA/NCAP, overlay P. Murphy© WWIIBRPG

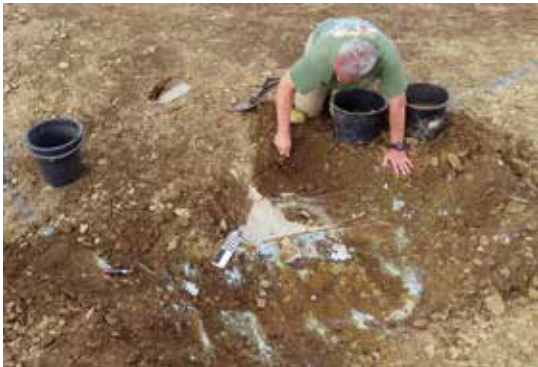
(Fig. 12.1) — Exposing the Horizontal stabilizer- RH elevator. USBC-007 (P. Murphy © WWIIBRPG).

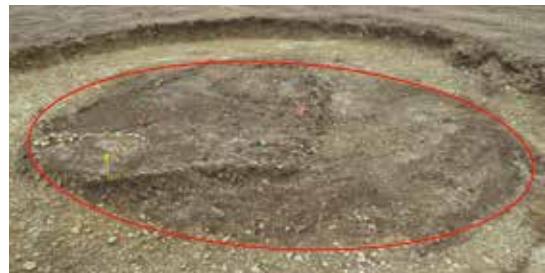
(Fig. 12.2) — 2021-034/USBC-002 (P. Murphy © WWIIBRPG).

Preliminary surveys of the site area indicated the deposited craters to be approximately 7 m in diameter and filled with metallic content. In USBC-002 (Fig 12.2) at a depth of 22 cm, strands of barbed wire fence, aircraft debris, and unexploded ordnance identified by SEDAL were also found. Shallow-buried UXO hazards must be anticipated in such an area given the combat history.

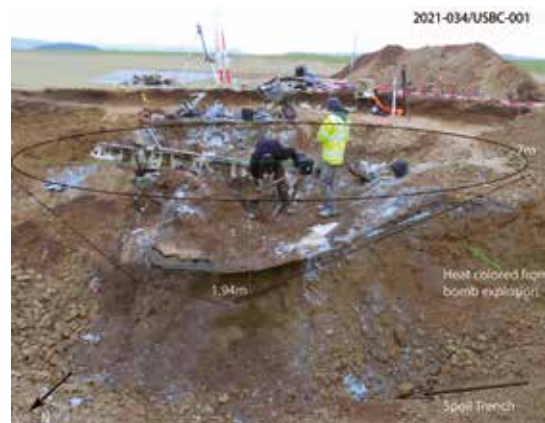
(Fig. 12.3) — USBC-001, exhibits the cone depression of the crater (Photo P. Murphy © WWIIBRPG).

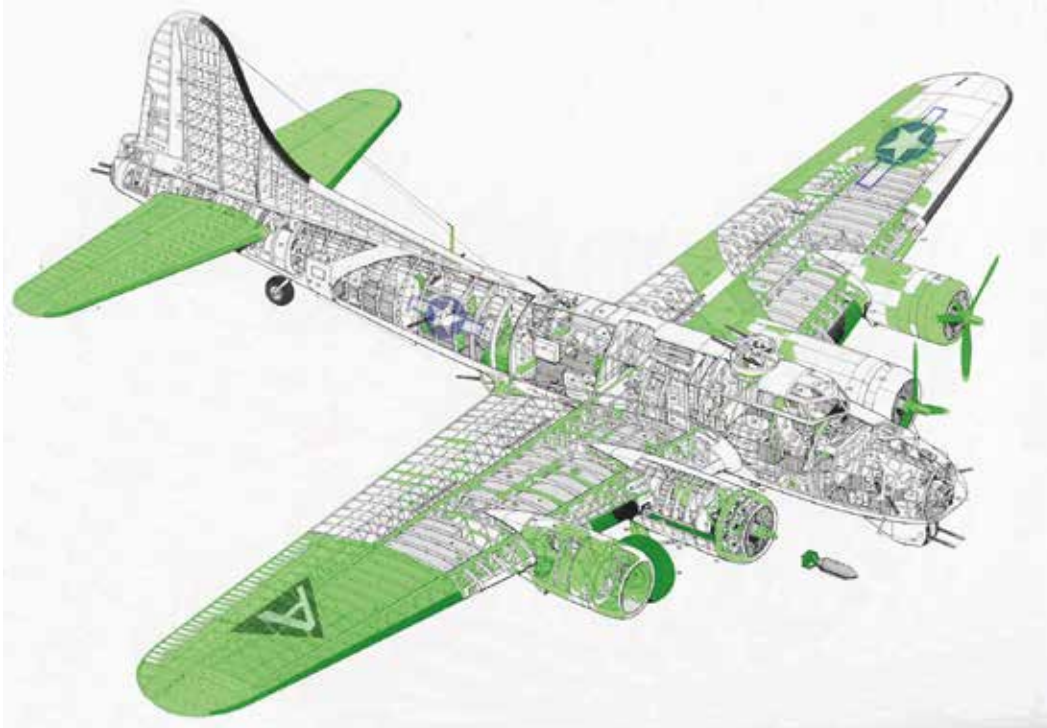
| (Fig. 13.1) — Aircraft structure diagram highlighting sections and parts recovered (Drawing M. Badrocke).

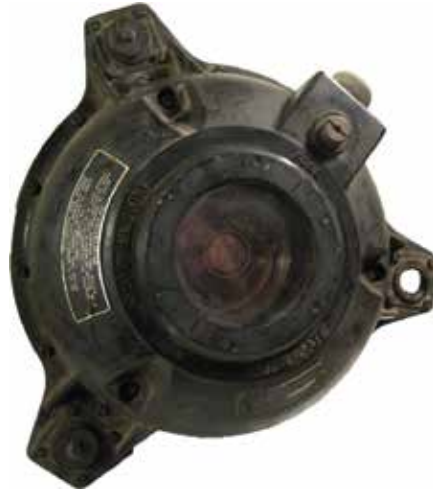
(Fig. 15.2) \_\_\_\_ comparison to a working Gyro-transmitter (P. Murphy © WWIIBRPG, photo source eBay).
